Model: DELL Inspiron 15 (3537) Alien
Notebook. Board number: Compal OEM, board
number LA-9982P, 4th generation single
CPU. Fault phenomenon: The water inlet
machine does not start when pressing the
switch.

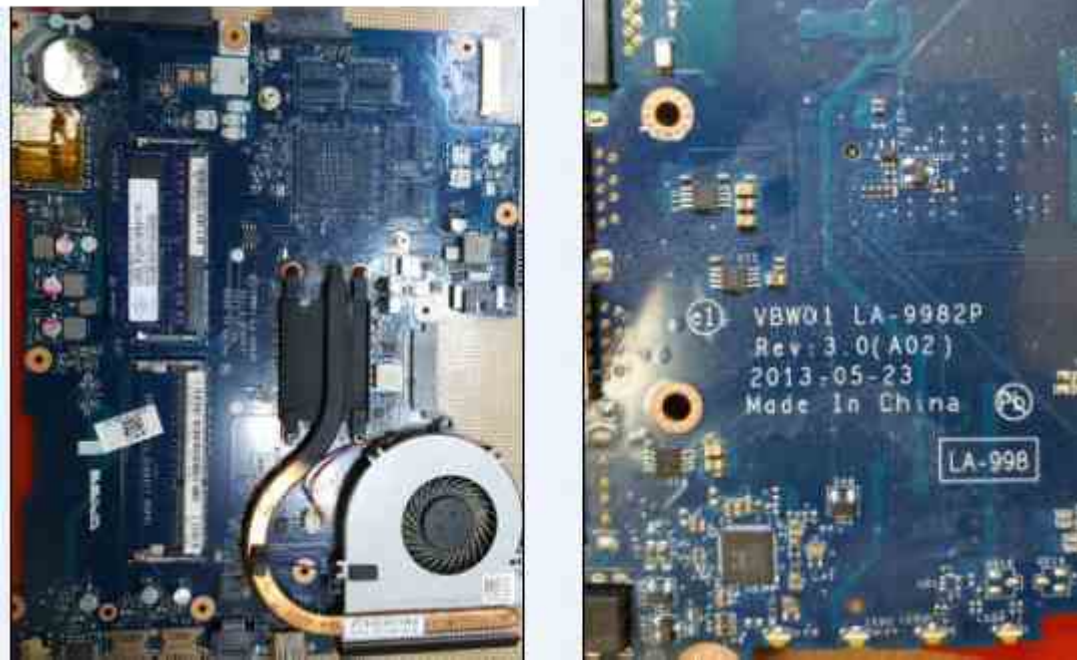
Maintenance process: The customer sent for repair, and the machine was a notebook computer. After
the machine is taken by itself, it is true that the machine will not be turned on first. Attached
with physical drawing and board number:

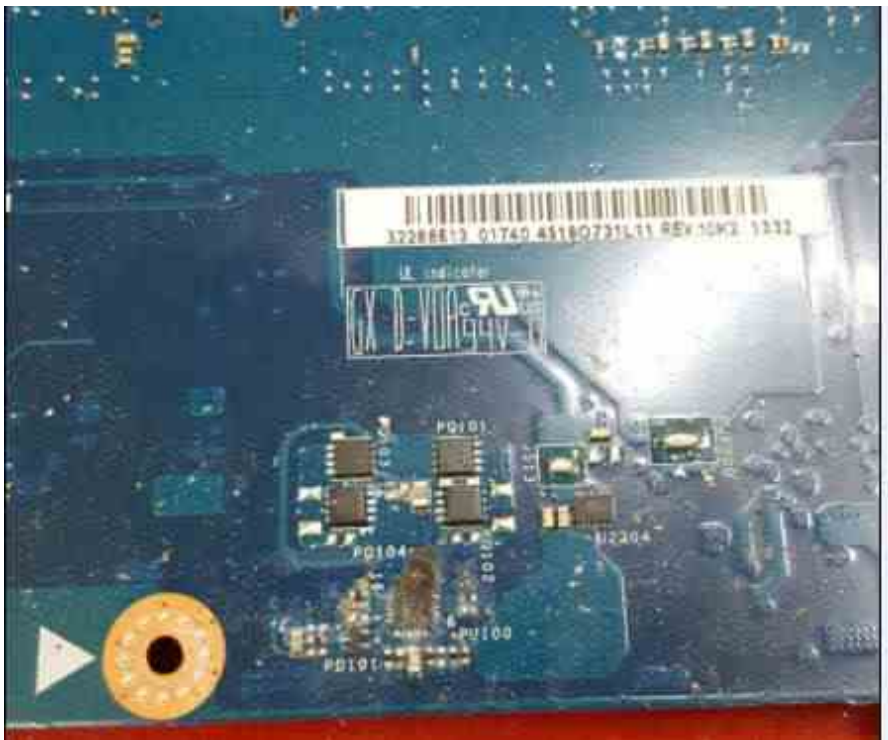
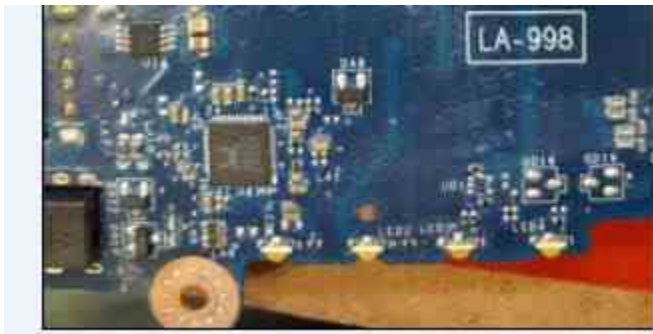
Quickly fold down the motherboard and check that there is water inflow in the standby part of the
notebook. The standby chip bit number is PU100, with physical diagram attached:

There is also water inflow on the sound card chip. The notebook motherboard is confirmed as not starting up first. So open the circuit diagram to analyze the repair machine.

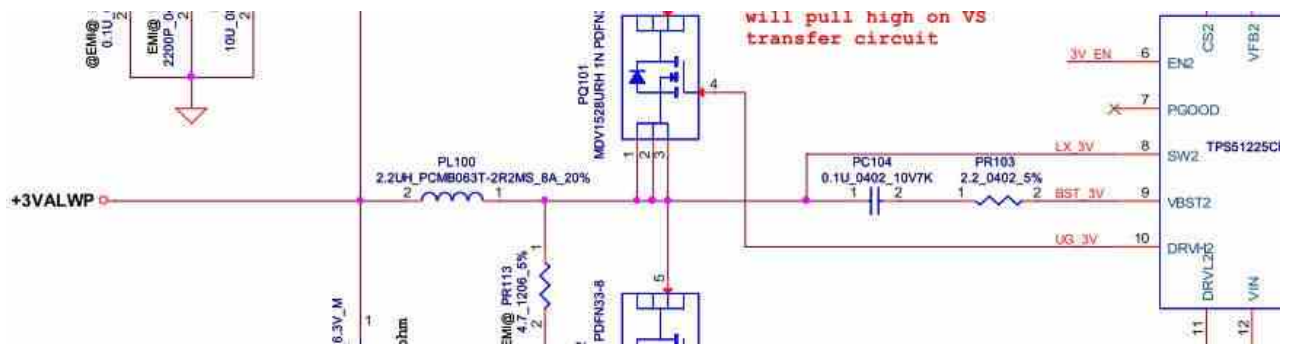
2. It has been found that the oxidation disconnection at pin 12 of the chip, and the signal supplies power to the 3V5V_B+ common point.

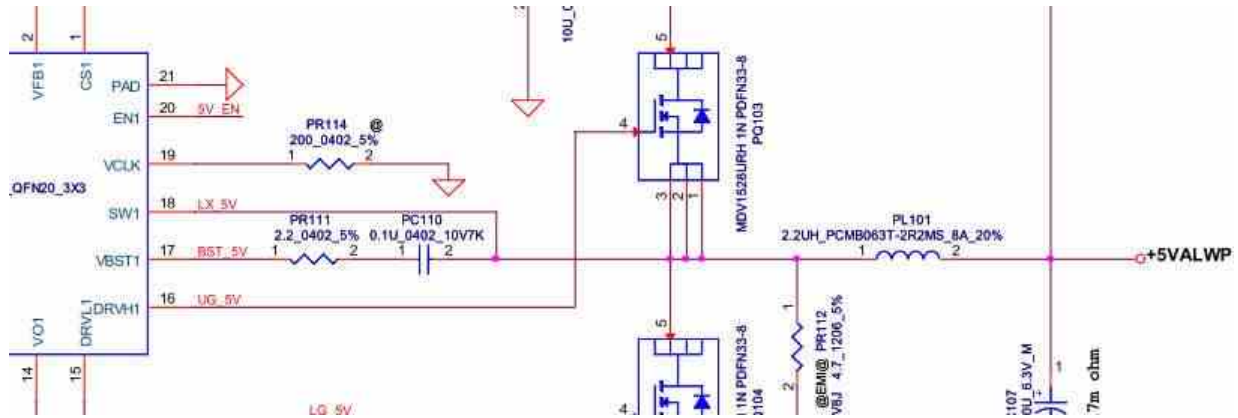
4. The measured PL101 + 5VALWP voltage is also 0V.

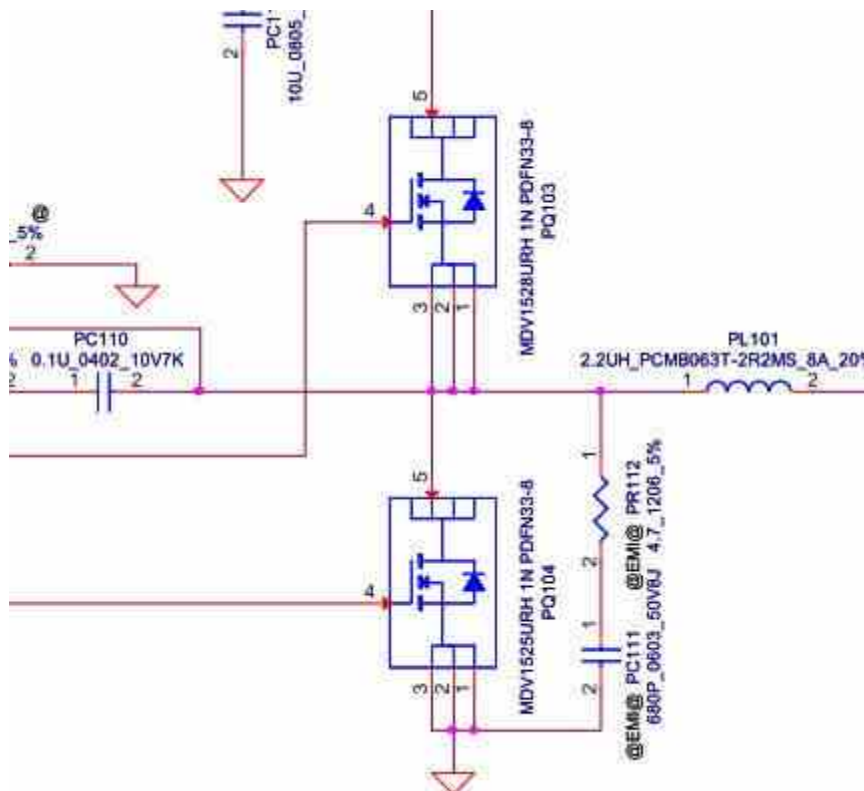
5. Notebook motherboard power-off again, with a multimeter to play PQ103, PQ104 on the fourth leg of 500 ohm, and 400 ohm, the resistance is OK.

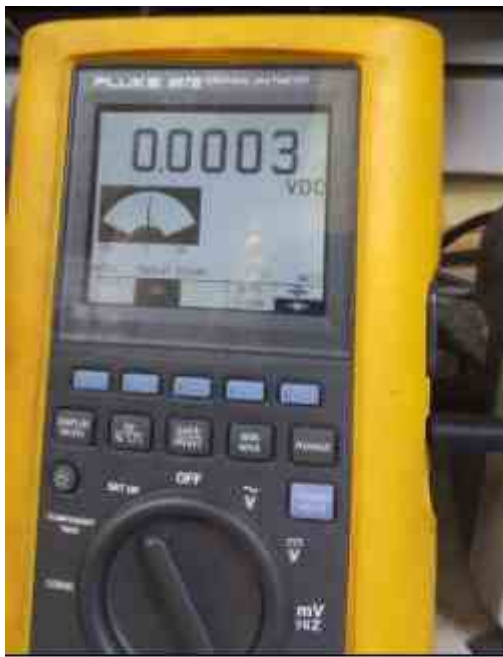
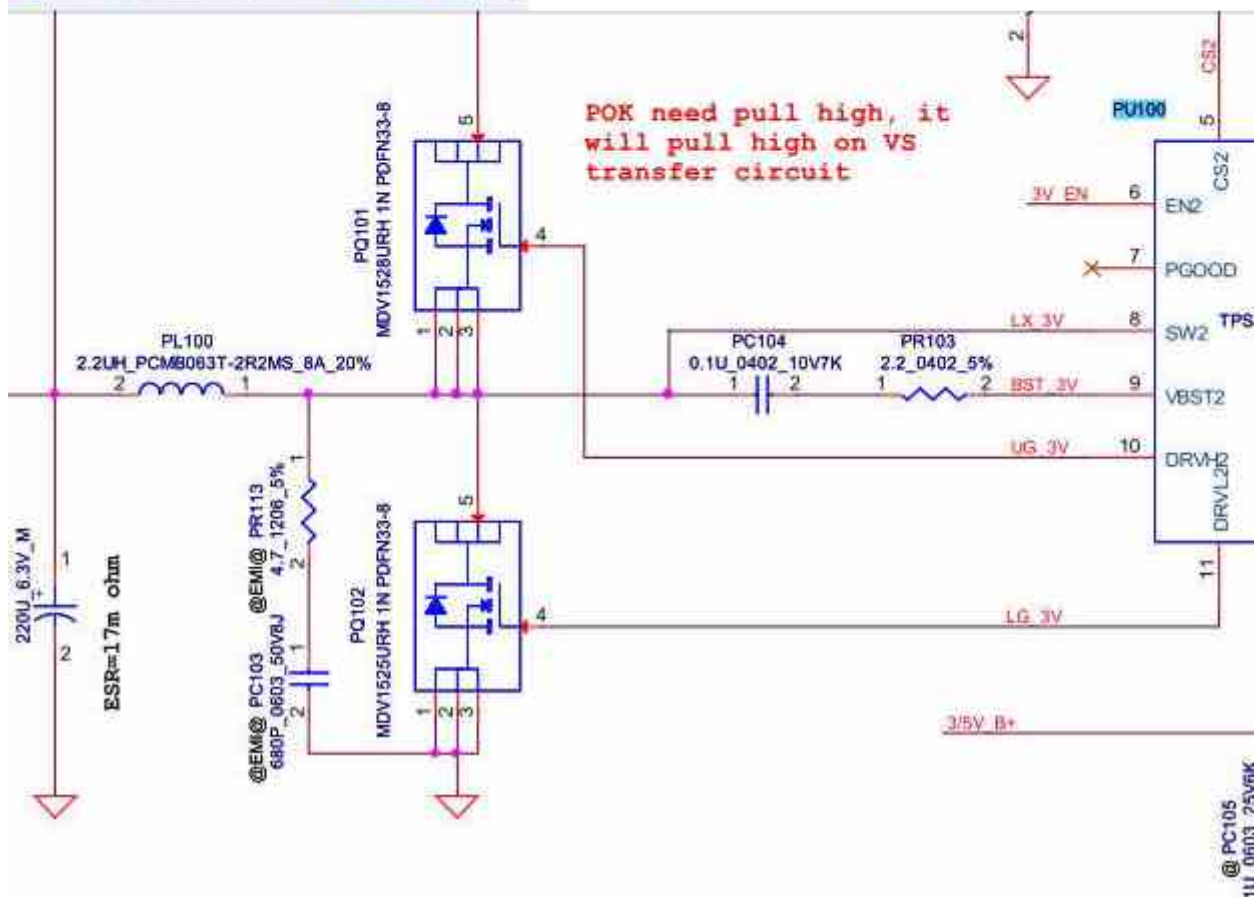
6. It is good to measure the fourth pin of standby power supply PQ101 pipe on the other side with multimeter for 480 ohms, but only 3 ohms for the fourth pin of PQ102 pipe. Actual measurement and schematic diagram are attached:

7. From the point of view of easy after difficult, first to fold off the PQ102 MOS tube, the value is still the same, the value is 3 ohm. Now analyzing from the drawings only

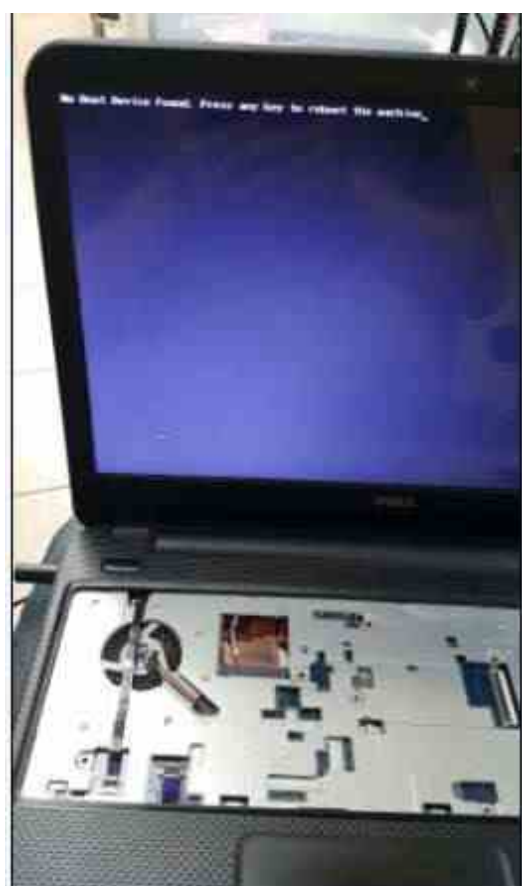
8. Motherboard installed screen and other interface small board, according to the startup key, the current all the way to the motherboard show bright machine OK.

Attached is a bright machine diagram.
