MS-7295 Ver:1.1

Title	Page
Cover Sheet	1
Block Diagram	2
AMD M2 940	3,4,5
System Memory	6,7
DDR Terminations	8
C51PVG	9-11
MCP51	12-15
PCI Slot 1,2	16
PCI-Express X 16 , X4 Slot	17
SIO-Winbond83627EHF / BIOS	18
LAN - REALTEK RTL8211BL	19
Azalia CODEC ALC883 & Interanl SPK	20
USB connectors	21
MS-6 ACPI Controller & MS-6+	22
PWM - ISL6566CRZ	23
IDE &FDD & FAN	24
ATX Connector / Front Panel	25
VGA Connector	26
DVI CONNECTOR	27
COM PORTS & TPM1.2	28
TEST POINTS & PCB	29
History	30-31
GPIO SPEC	32
POWER OK MAP	33
POWER MAP	34
MANUAL PARTS	35

Micro Star Restricted Secret		
Title	Cover Sheet	Rev 1.1
Document Number	MS-7295	
MICRO-STAR INT'L CO., LTD. No. 69, Li-De St., Jung-Hsi City, Taipei Hsien, Taiwan http://www.msi.com.tw		Last Revision Date: Wednesday, August 01, 2007 Sheet 1 of 35

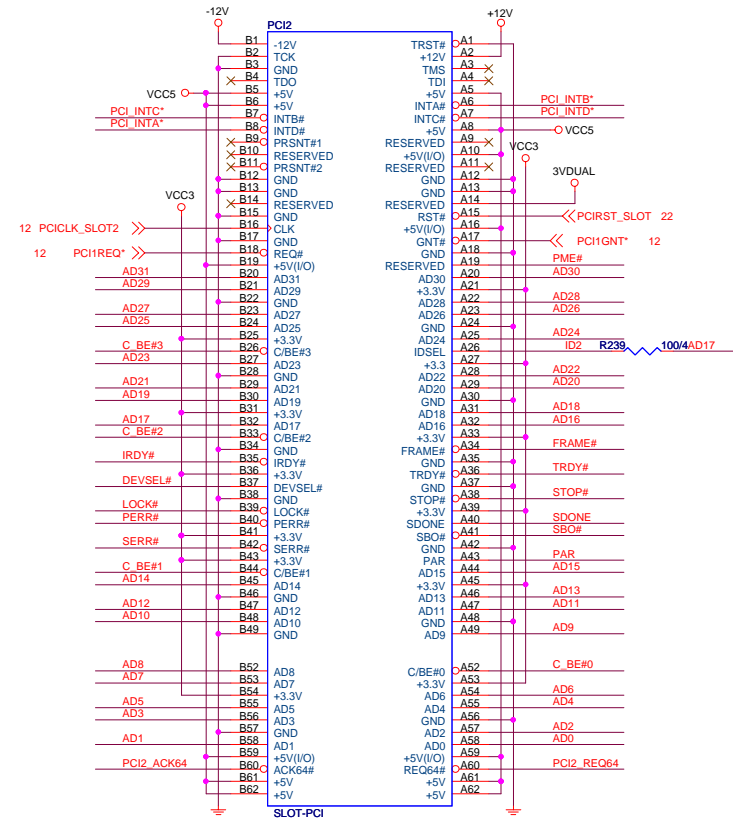
PCI SLOT 2 (PCI VER: 2.3 COMPLY)

IDSEL = AD17
MASTER = PCI2REQ*
PCI2GNT*

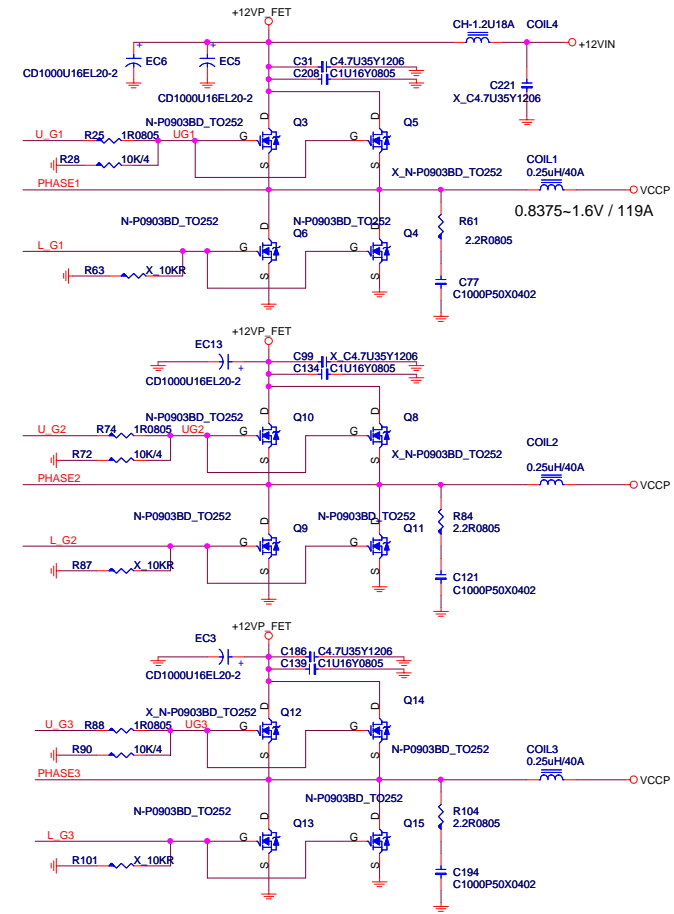
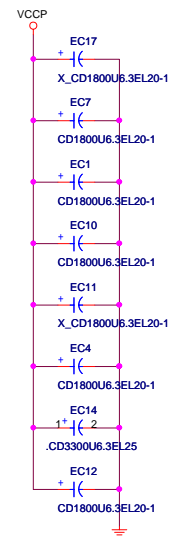
Voltage Regular Module

IPF06N03LA
C100U2SP
.CD3300U6.3EL25
560u_2.5V
1800UF/6.3V
0.6uH/40A
CH-1.2U18A

Rds(on)=8.7mΩ (@4.5V, 30A), Vgs(ON)=1.2~2V, Id=50A, Ciss=3110pf, Qg=10nC, Vds=25V, Vgs=±20V
ESR<13mΩ, Ripple cur.<2.7A, LC<12uA, 105C
ESR<12mΩ, Ripplecur.<2800mA, 105C, longlife3000hrs, KZJSeries
ESR=6mΩ, Ripplecur.=4400mA, Lc.<500uA, 105C/2000hrs
ESR<12mΩ, Ripplecur<2350mA, 105C, longlife change from 2000hrs to 3000hrs ,KZJ series
0.6u/20%, Isat=40A, Rdc=1.2m ohm, PEW wire
1.2u/20%, Dip-2/vertical 7.5mm, 1.2ψ/5.5turns, 18A

modify VRM solution in OC
R2 change to 75K ohm 14
R36 change to 120K ohm
R42 change to 2K ohm
remove Q5,Q8,Q12 in bom
Q(4,6,9,11,13,15) change to NIKOS 0903BDG (D03-0903BDB-N03)

Page28 : Change JCOM1 color to black
Page21 : L10 & L11 change to common choke
Page23 : modify VRM solution
Page17 : PCI-express X16 CHANGE TO AUTOMATIC CLIP
Page21 : JUSB1 & JUSB2 change to 2*4pin header without housing
Page28 : JCOM1 change to black color
Page28 : JAUD1 change to blue color
Page30 : CPU retention module change vender to AVC
Page18,22,25 : Modify "Restore On AC Power Loss function" failed
Page10,27 : Add amplifier to solve RGB signal quality on 2VGA monitor.
Page22 : add EC49 & EC25 for VCC3
