**BIOSTAR GROUP****VIA P4X400 + VIA VT8235CD Chips****U8798P****(U8798 Pro)****VER:1.3**

TITLE	SHEET
COVER SHEET	1
SYSTEM BLOCK	2
GENERAL SPEC.	3
CHANGE LIST	4
AMD-K7 SOCKET-A	5,6
NORTH BRIDGE (VIA KT333 CF)	7,8,9,10
SOUTH BRIDGE (VIA VT8235)	11,12,13
CLOCK SYNTHESIZER	14
DDR DIMM 1&2&3	15,16,17
AGP8X SLOT	18
PCI SLOT	19,20,21
CNR SLOT	22
IDE CONNECTORS	23
USB	24
AC'97 CODEC,AUDIO / GAME PORT	25
LPC I/O,FDD	26
COM/LPT PORTS, RI, WOL, WOM & FRONT PANEL, BUZZER	27
ATX POWER & BYPASS CAPACITORS	28
VCC_CORE DC-DC CONVERTER	29
MISCELLANEOUS DC-DC CONVERTERS, SUSPEND TO RAM(STR), FID	30
PS2 , FAN , Anti-POP	31
LAN PHY	32
CAP	33

1. CPU --- AMD Socket-A(2-Phase Power)
2. CHIPSET --- VIA KT333CF + VT8237
3. MEMORY --- 3 DDR SDRAM(Max. 3GB)
4. SLOTS --- AGP(4X)x1, PCIx5, CNRx1
5. CODEC --- C-Media CMI9739A 6-Channel Audio
6. LAN PHY --- VIA VT6103
7. SATA --- Marvell 88I8030
8. PCB Size = 30.5cmX20.5cm, 4-Layer

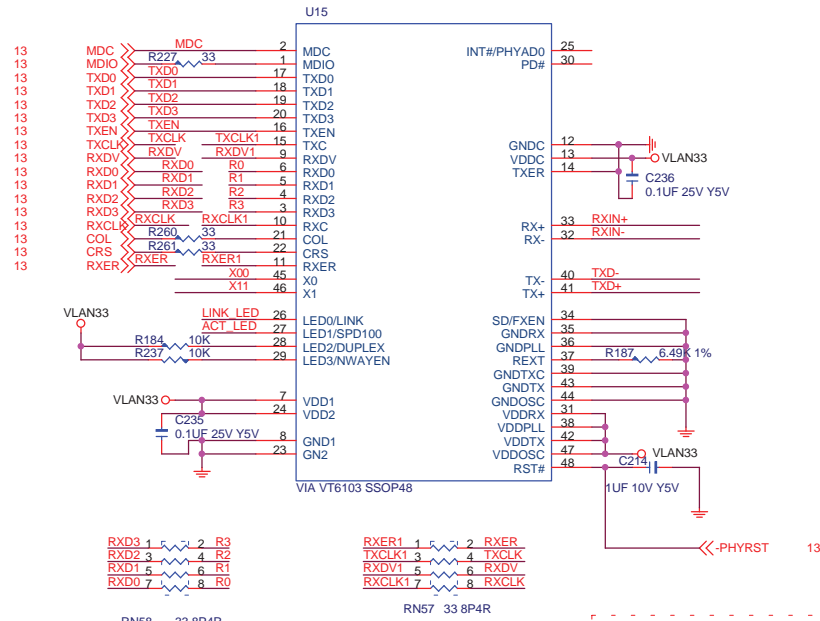
# Connect to MII interface
