Model : P75/55IMx

Intel Merom CPU + PM965 + ICH8-M Chipset
Santa Rosa plantfrom (No supported AMT)

PCB P/N: 37GP55000-C0
PCBA P/N: 82GP55000-C0

UNIWILL COMPUTER CORP.			
File		P75/55IMx	
Size	Document Number	INDEX	
	3581	Rev C	
Date	Tuesday, March 13, 2007	Sheet	1 of 37

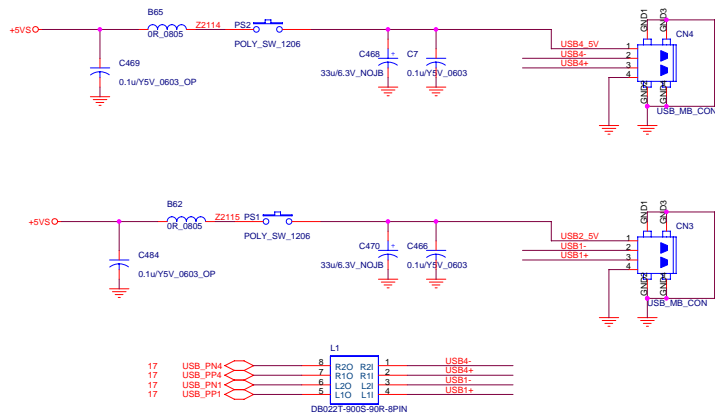
USB PORT CONN

USB CONN change from 3 ports to 2 ports @ REVA2
One USB ports W/I charger remove to daughter board and add eSATA port@ REVA2
