MS-7435-0A Block Diagram

MICRO-STAR INT'L CO., LTD.			
Title			
COM PORT&HWM			
Size	Document Number	Rev	
	MS-7435	0A	
Date	Thursday, October 23, 2008	Sheet	15 of 33

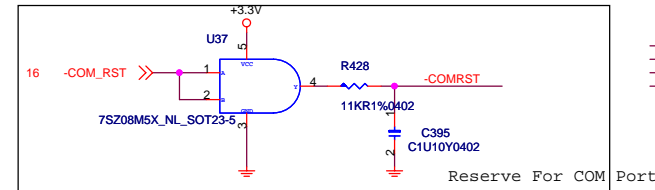
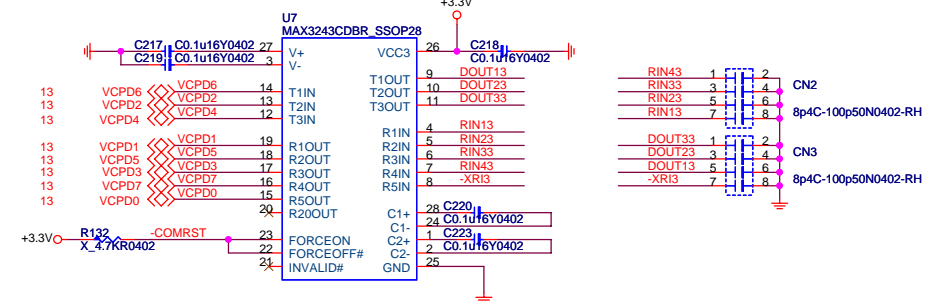
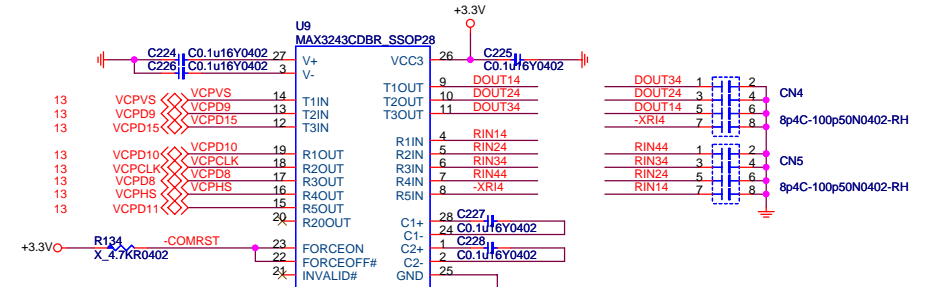
VIA Suggest:The VCP port and COM port is multiple function and it is recognize which function is after Reset.
=>So, we recommend use "Reserve circuit for COM port" by default.
Unmount R132,R134
Mount U37,R428,C395,R332

VCPD10	EXSR13[5]	CPUCK/MCK CLOCK Select
		* 0: from NB 1: from external
VCPD9	EXSR13[4]	PCI Signal test output enable
		* 0: Disable 1: Enable
VCPD7	EXSR13[0]	GFX CLOCK Select(VCK/LCDCK/ECK/TVCK)
		* 0: Refer internal 1: From external
VCPD6	EXSR12[6]	DVP0 port/Capture port select
		* 0: Capture port 1: DVP0 port
		★stand for default setting

1.The VCP port and COM port is multiple function and it is recognize which function is after Reset.
=>So, we recommend use "Reserve circuit for COM port" by default.
Unmount R132,R134
Mount U37,R428,C395,R332

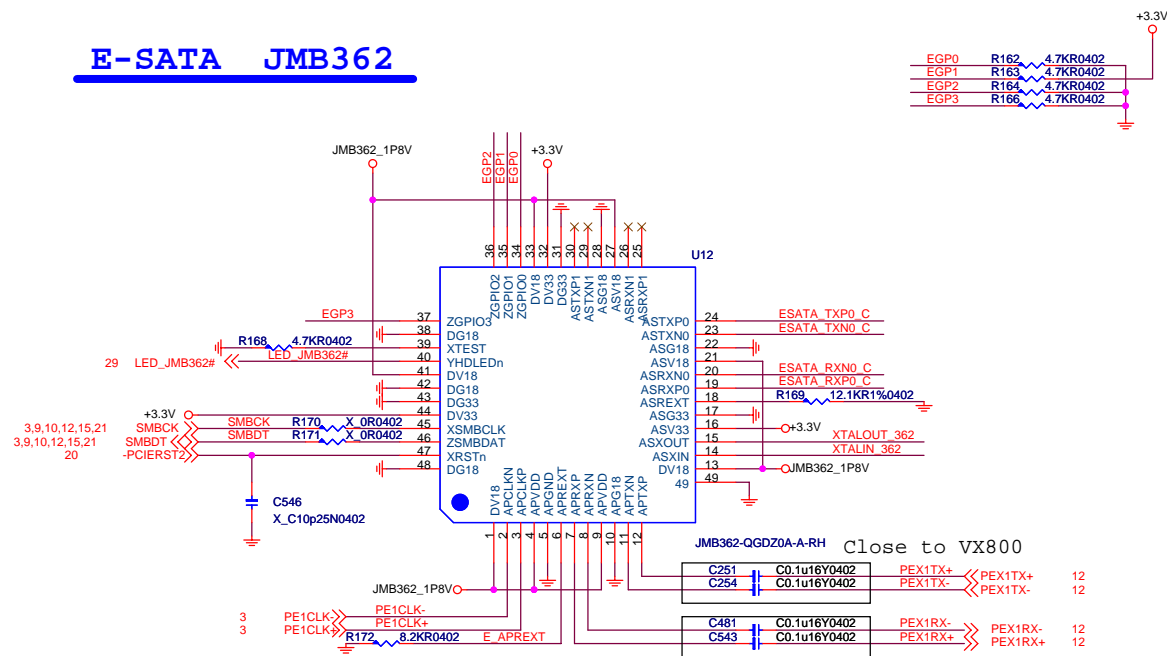
E-SATA JMB362

Close to U12

PS: The AC Cap should be place at Transition side of Device if your device is onboard.

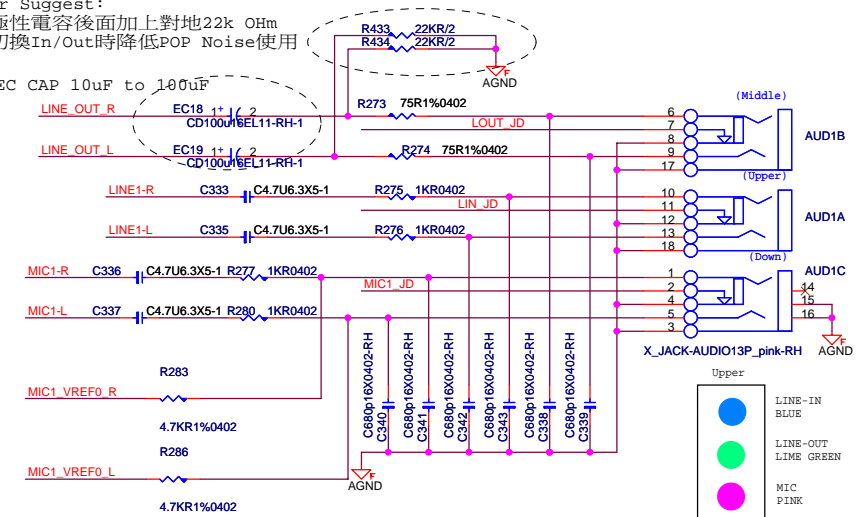
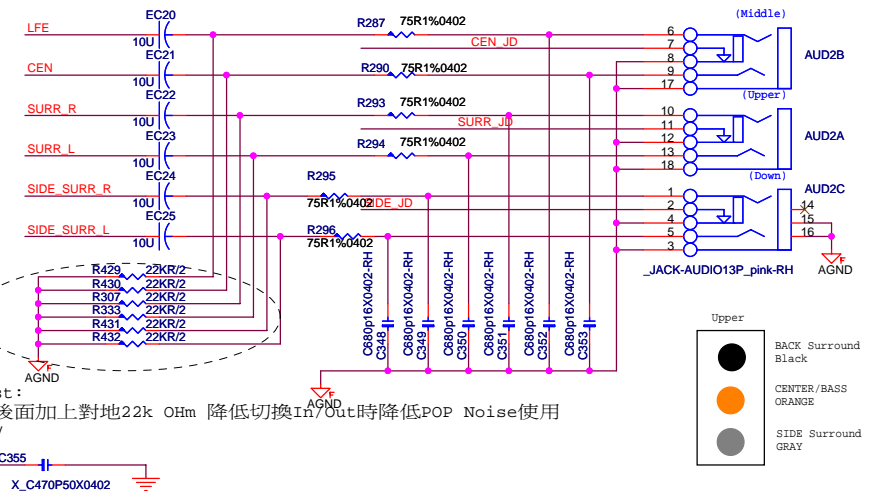
在有極性電容後面加上對地22k OHm
降低切換In/Out時降低POP Noise使

Change Line Out EC CAP 10uF to 100uF

在有極性電容後面加上對地22k OHm 降低切換In/Out時降低POP Noise使用

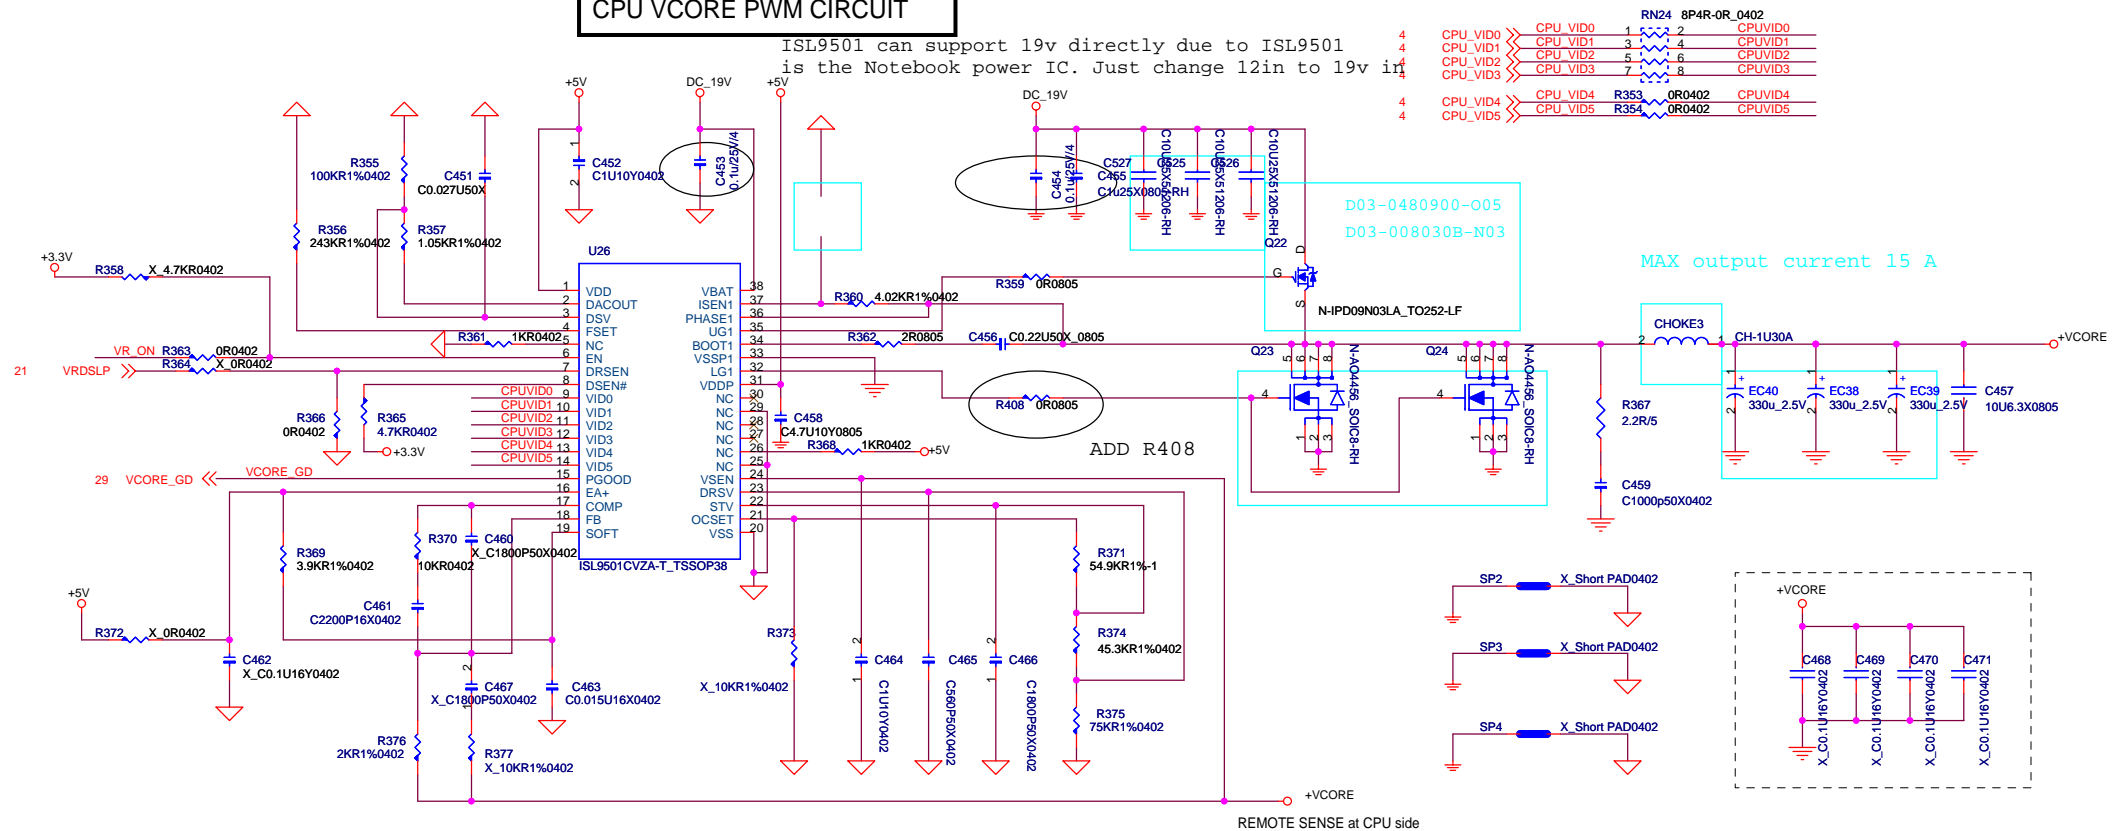
CPU VCORE PWM CIRCUIT

ISL9501 can support 19v directly due to ISL9501
is the Notebook power IC. Just change 12in to 19v in

Remove:CLK_EN to P3,-CPUSTP to P3&21,VCCSENSE to P5,-PSI to P4

VIA suggest : If your CPU PWM is not CLK enable function pin.
=>We recommend the CLK enable pin connect 10k ohm to +3.3V directly.
Unmount Q25 and C481,R379

1.VIA suggest : If your CPU PWM is not CLK enable function pin.
=>We recommend the CLK enable pin connect 10k ohm to +3.3V directly.
Unmount Q25 and C481,R379
